Manhole Inspection Summary

Manhole # S45CC_010MH

Insp Date: **2/10/10 12:08 PM**

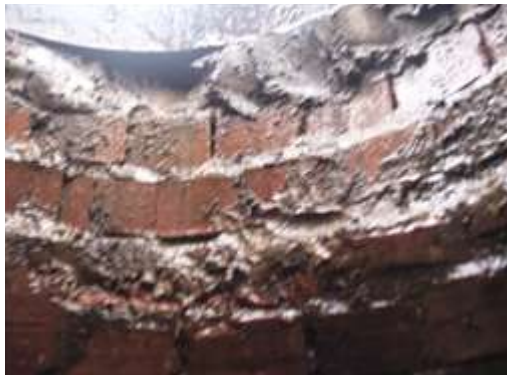
Defect 3

loose bricks

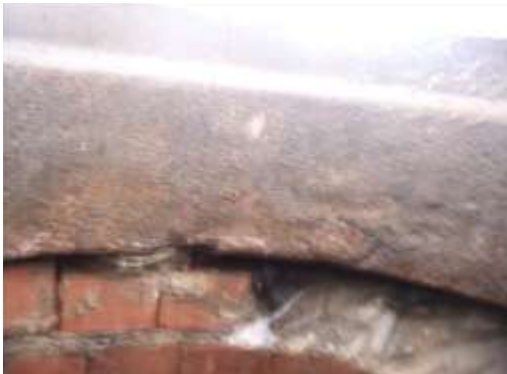
Defect 2

loose bricks

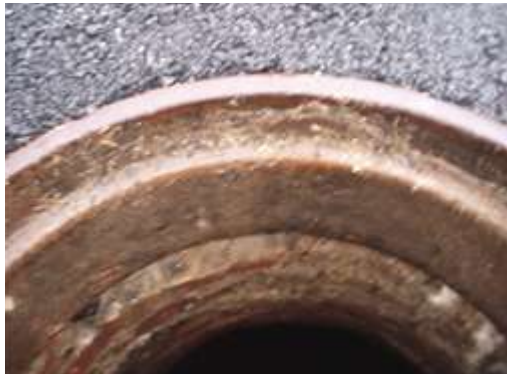
Defect 1

☒ **Leaks**

frame leaks

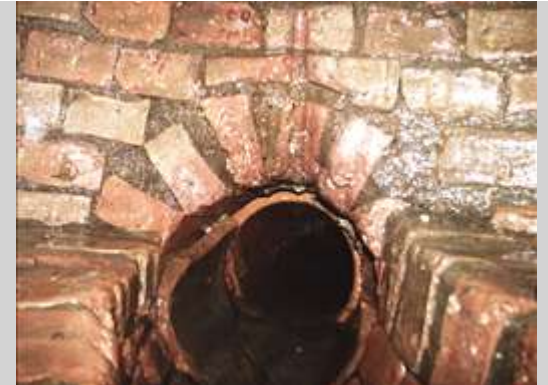
12 O'Clock Outflow

12 in. Circular Gravity Sewer
Pipe Out @ 12 O'Clock

Pipe Height: **15.6** (in.) Rod and Bar (Angled)
Pipe Material: **Clay** ☐ Pipe Lined
Invert Depth: **9.83** (ft.) Flow Characteristics: **Fast**
Deposits: ☒ None ☐ Mud ☐ Sludge ☐ Debris ☐ Grease
Silt Depth: (in.) Deposits Extent:
Infiltration: **None** Pipe Seal Cond: **Sound**

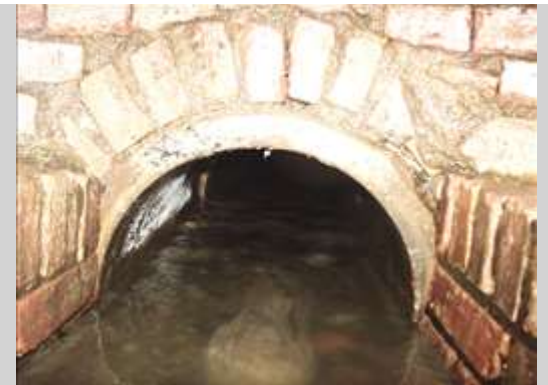
6 O'Clock Inflow

12 in. Circular Gravity Sewer
Pipe In @ 6 O'Clock

Pipe Height: **15.6** (in.) Rod and Bar (Angled)
Pipe Material: **PVC** ☐ Pipe Lined
Invert Depth: **9.67** (ft.) Flow Characteristics: **Fast**
Deposits: ☒ None ☐ Mud ☐ Sludge ☐ Debris ☐ Grease
Silt Depth: (in.) Deposits Extent:
Infiltration: **None** Pipe Seal Cond: **Sound**

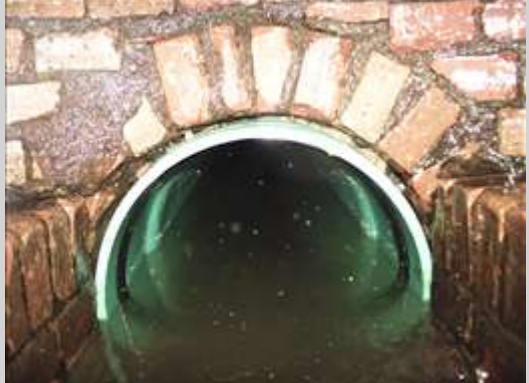
9 O'Clock Inflow

Pipe Seal Cond: **Cracked**
